# Eldorado Area Water and Sanitation District Asset Management Plan

Eldorado Area Water and Sanitation District

January 2016

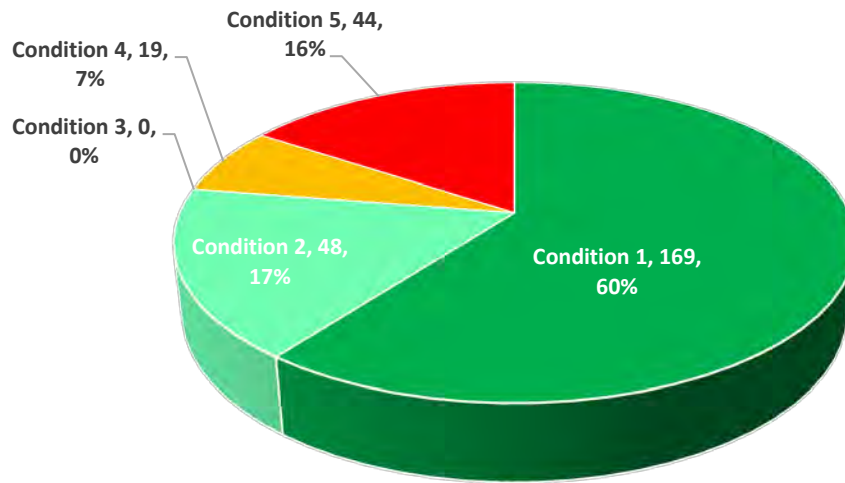
The results of the vertical asset assessment conducted in 2011 are shown on Figure 2. Overall, 77 percent of the assets were in condition state 1 or 2 (new to average condition).

Figure 2. Eldorado Area Water and Sanitation District Vertical Asset Condition (2011)

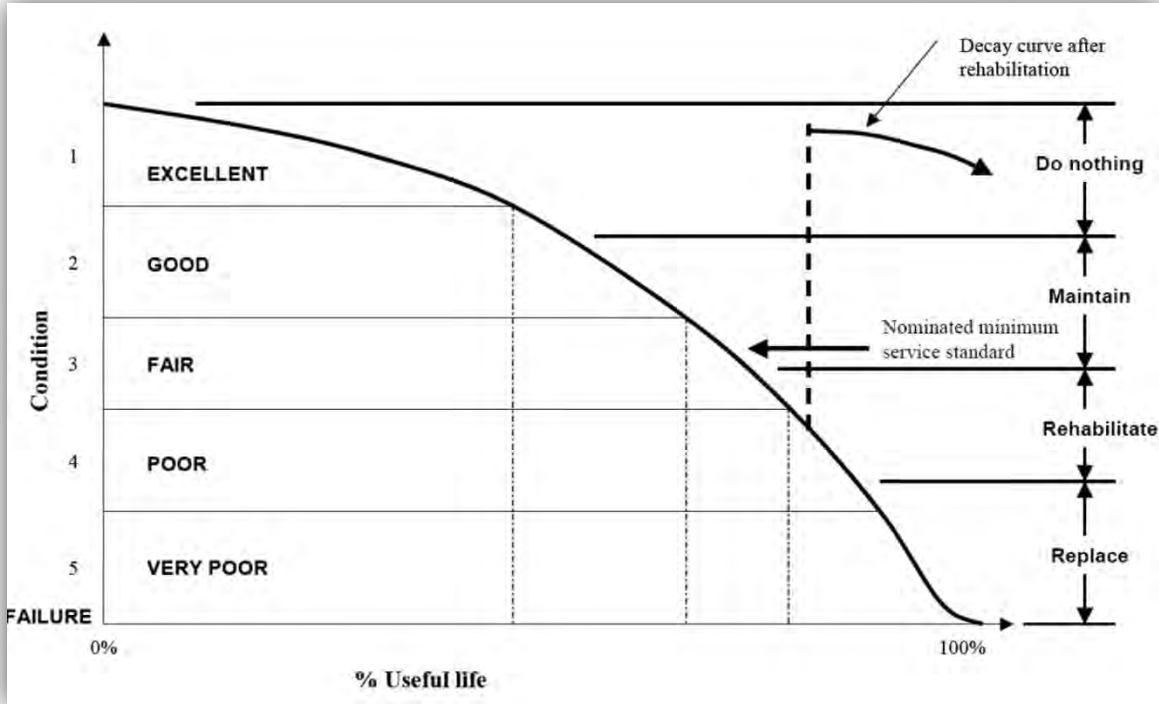
As with vertical assets, linear assets receive a 1 to 5 condition rating based on the assets position on the curve. The condition based on age chart is shown on Figure 3.

Figure 3. Condition from Pipe Age

LSL = indicates a relatively long service life for the material resulting from some combination of benign ground conditions and evolved laying practices etc.

SSL = indicates a relatively short service life for the material resulting from some combination of harsh ground conditions and early laying practices, etc.

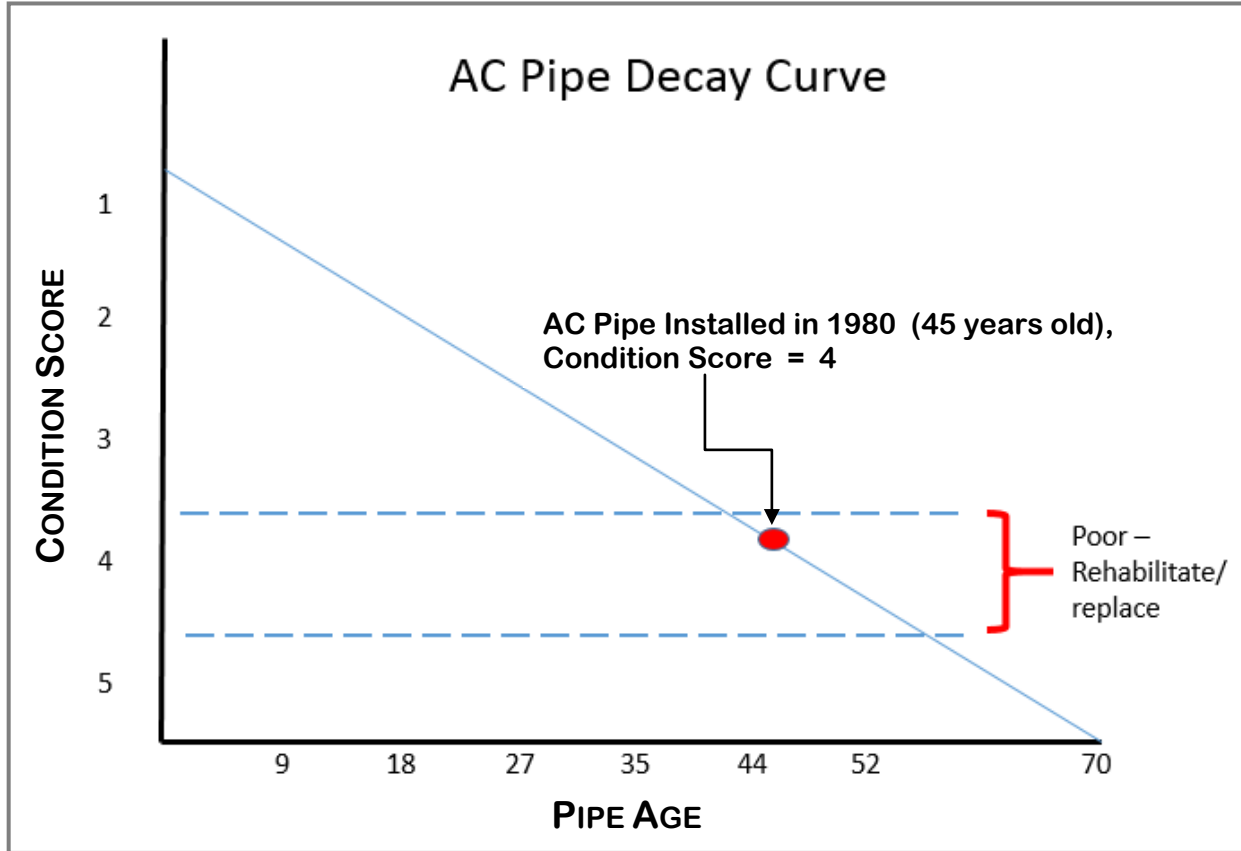
The asset condition of linear assets is determined by material construction and age. As the installation date data are compiled, the remaining life of linear assets can be approximated. An example of how the pipes will be assessed based on the various curves is shown on Figure 4.

Figure 4. Example Plot of AC Pipe Decay Curve for 45-Year-Old Pipe

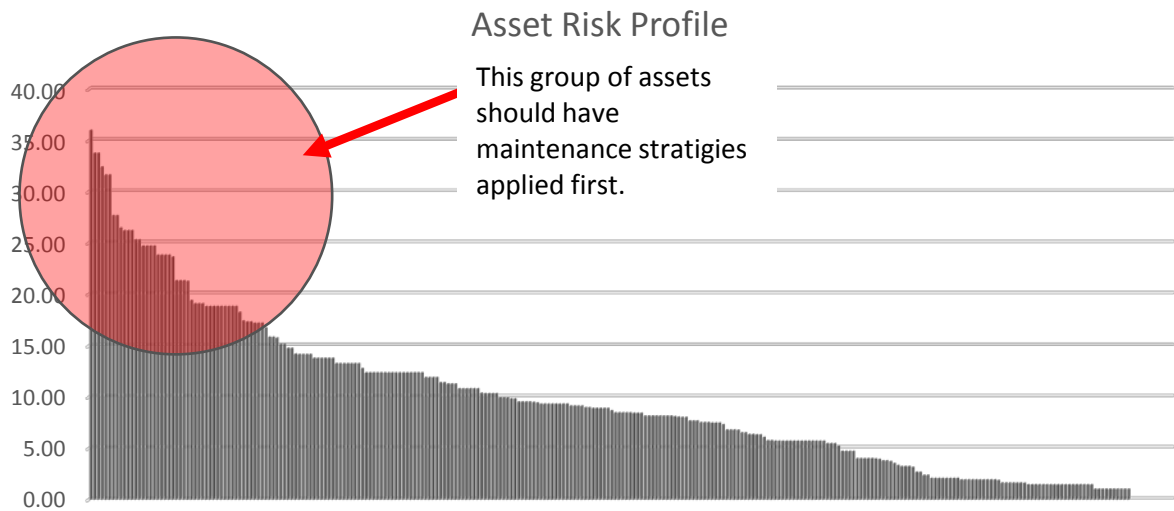
Once consequence was assigned to each asset, a field condition assessment was completed in 2011 to determine the condition of assets, operation and maintenance protocols in place, and performance. Once this was complete, an asset risk profile was generated. The asset risk results from the 2011 assessment is shown on Figure 5.

Figure 5. Asset Risk Profile (2011)
